# ABS Plastic Coupling Cracking

**Dirk Duffner**  
**Duffner Engineering**  
**[dduffner@duffnerengineering.com](mailto:dduffner@duffnerengineering.com)**

# Summary

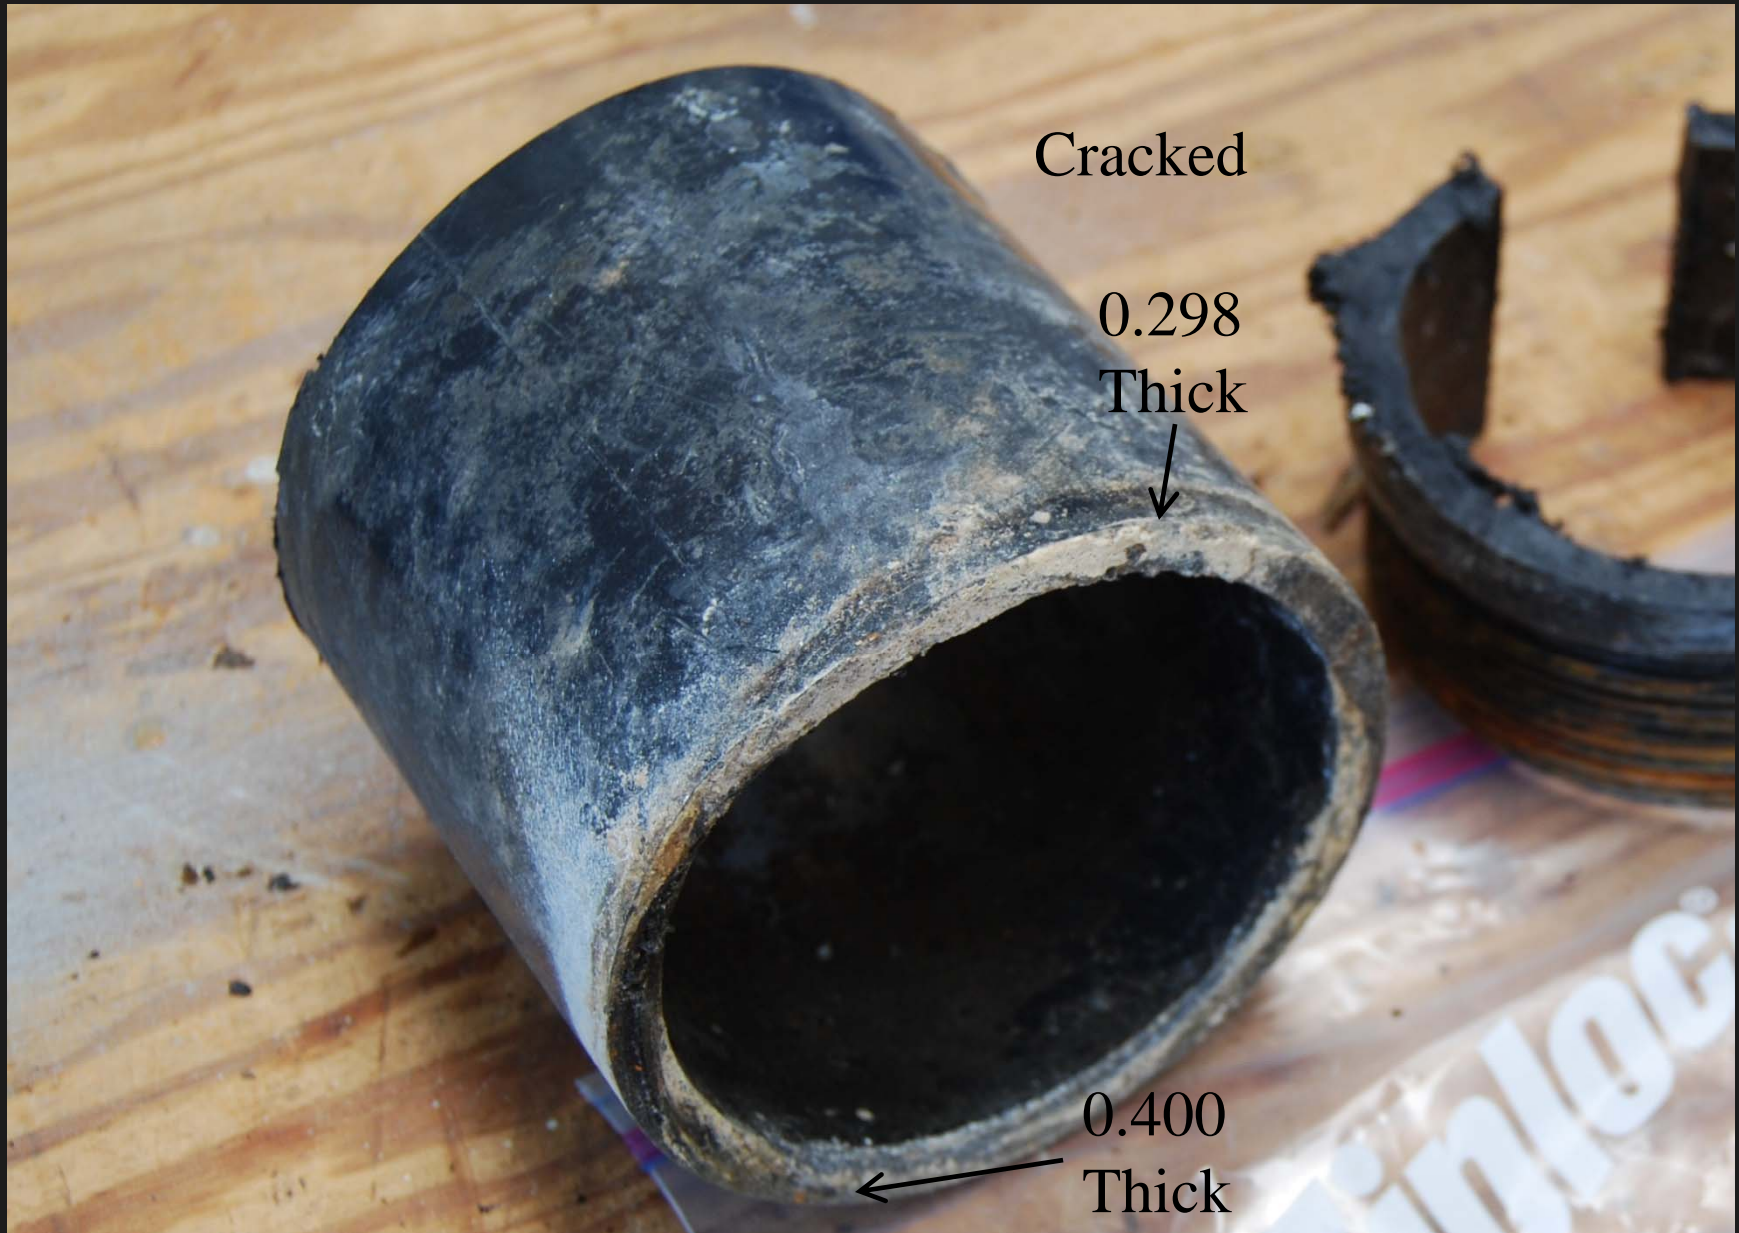
# Subject ABS Plastic Coupling

- **Acrylonitrile Butadiene Styrene (ABS) plastic couplings installed as part of a water closet carrier system were found to be leaking in many of the rooms of a local hotel. The installer was blamed for his alleged use of certain thread sealing compounds that were incompatible with ABS. Our examination found that the leaks resulted from cracks through the coupling walls that exhibited features common to creep rupture or environmental stress cracking (ESC).**

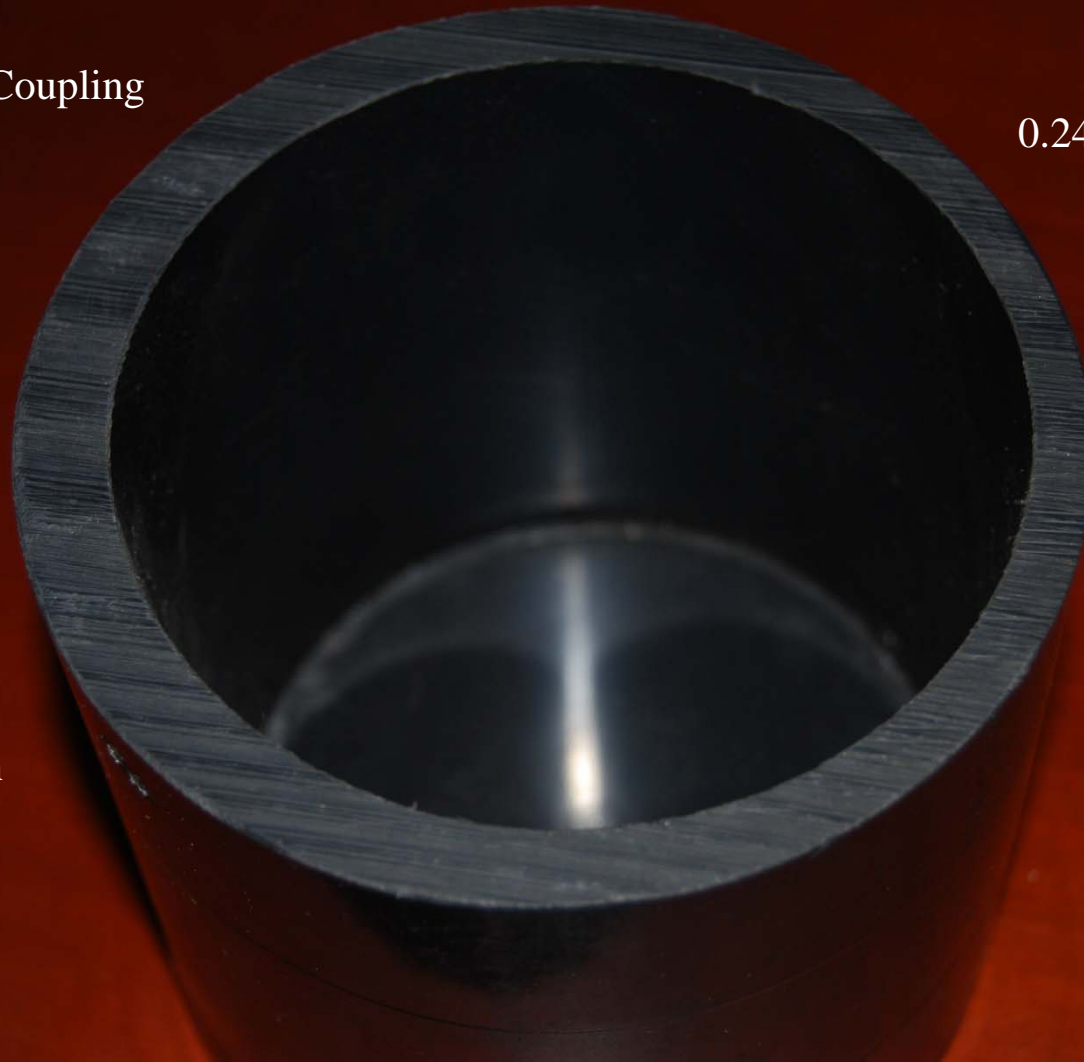
# OD and ID Not Concentric

New Unused Coupling

0.248 in

0.424 in

- **OD = 4.607 in**
- **ID = 3.933 in**
- **T = 0.340 in**
- **L = 6 in from tip to end of threads**
- **ID not concentric with OD**
  - **Thinnest section = 0.298 in**
  - **Thickest section = 0.400 in**
  - **Offset from average = 0.06 in**
    - **Causes contact force at tip of coupling**
- **E = 289,000 psi**

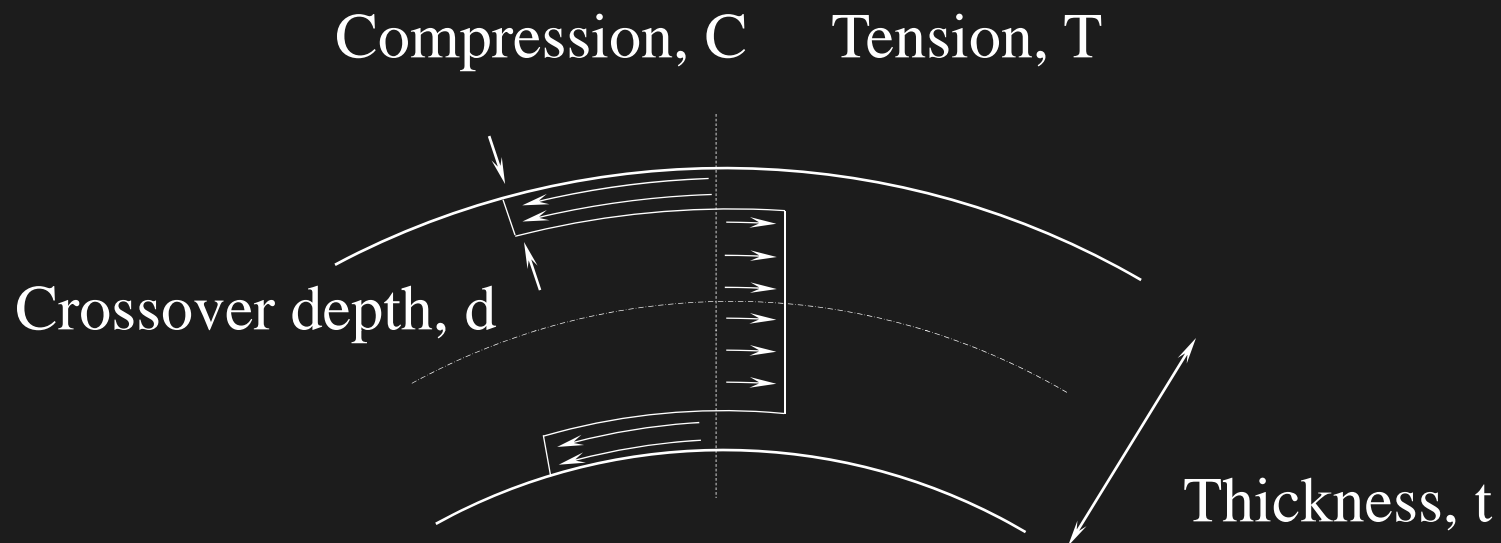
# Residual Stress Distribution

Force Balance Through Cross Section

$$C d = T (t/2 - d)$$

$$T = (C d) / (t/2 - d)$$

- **Average measured compressive stress to crossover depth**
  - Cracked Specimens -5.6 ksi
  - Uncracked Specimens -3.3 ksi
- **Crossover depth 0.01 to 0.02 in**
- **Average  $d = 0.014$  in**
- **Average  $t = .338$  in**
- **Average Tensile Residual Stress**
  - Cracked Specimens 0.51 ksi
  - Uncracked Specimens 0.30 ksi

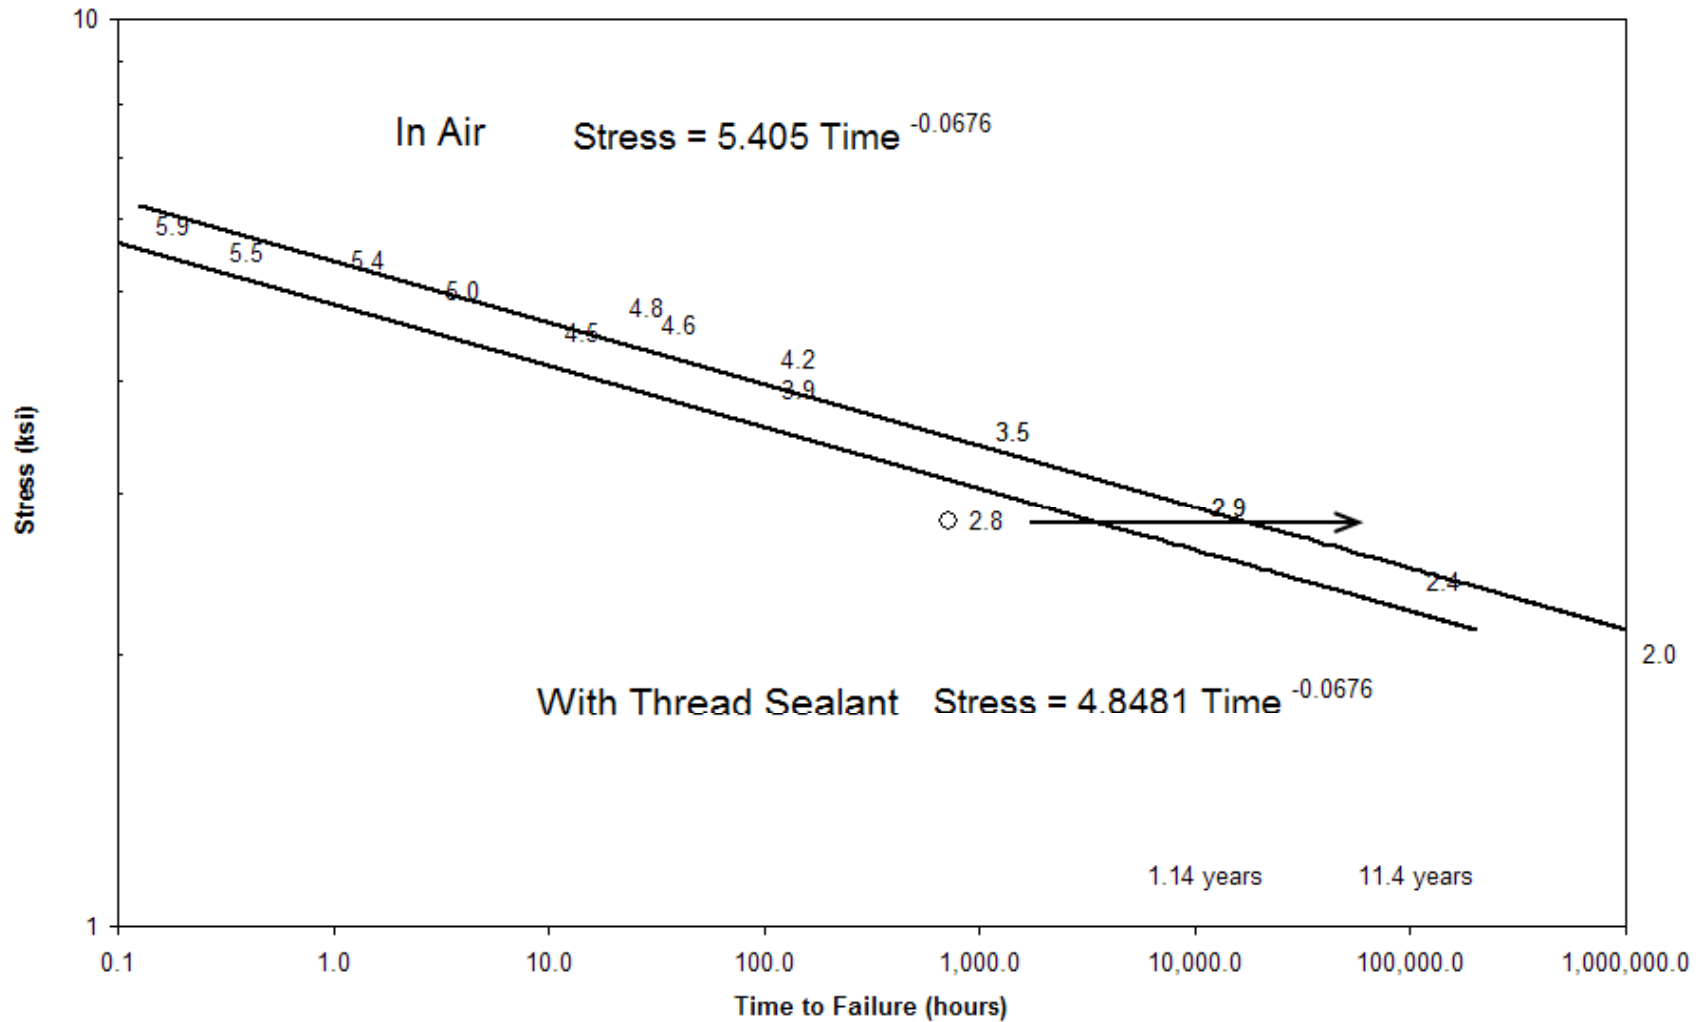
# Material Strength Curves

Creep Rupture of ABS

- **Cracked**       $2.13+0.51=2.64$  ksi – 4.6 yr
- **Uncracked**    $2.13+0.30=2.43$  ksi – 15.6 yr

- **Cracked**       $2.13+0.51=2.64$  ksi – 0.9 yr
- **Uncracked**    $2.13+0.30=2.43$  ksi – 3.1 yr
